DEPARTMENT OF TRANSPORTATION

Quality Assurance and Source Inspection

Contract #: 04-0120F4Cty: SF/ALA Rte: 80 PM: 13.2/13.9File #: 69.28**WELDING INSPECTION REPORT****Resident Engineer:**Siegenthaler, Peter**Address:** 333 Burma Road**City:** Oakland, CA 94607**Report No:** WIR-018092**Date Inspected:** 04-Nov-2010**Project Name:** SAS Superstructure**OSM Arrival Time:** 700**Prime Contractor:** American Bridge/Fluor Enterprises, a JV**OSM Departure Time:** 1900**Contractor:** Zhenhua Port Machinery Company, Ltd (ZPMC), Changxing Island **Location:** Shanghai, China**CWI Name:** Xu Le Feng**CWI Present:** Yes No**Inspected CWI report:** Yes No N/A**Rod Oven in Use:** Yes No N/A**Electrode to specification:** Yes No N/A**Weld Procedures Followed:** Yes No N/A**Qualified Welders:** Yes No N/A**Verified Joint Fit-up:** Yes No N/A**Approved Drawings:** Yes No N/A**Approved WPS:** Yes No N/A**Delayed / Cancelled:** Yes No N/A**Bridge No:** 34-0006**Component:** TOWER & OBG Components**Summary of Items Observed:**

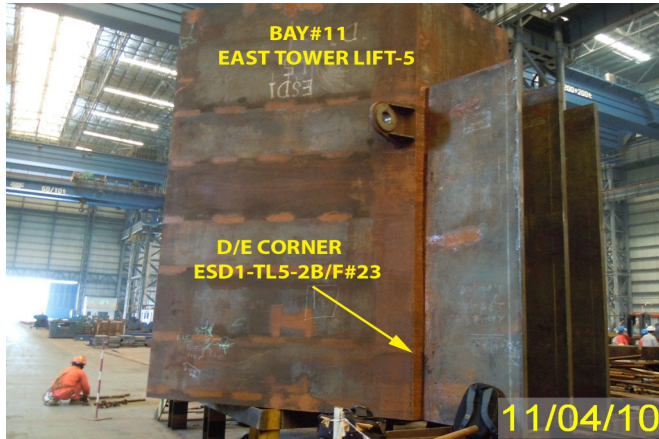
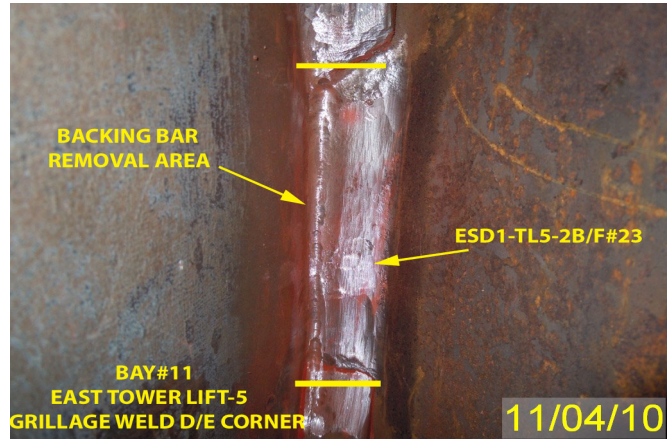
During the Caltrans Quality Assurance (QA) in-process observation on East tower lift-5 grillage, this QA Inspector discovered the following issue:

- ZPMC offered NWIT #007231 for Visual Testing (VT) and Magnetic Particle Testing (MT) of a repair to an area of backing bar non-fusion.

- The weld designation is ESD1-TL5-2B/F#23.

- ZPMC personnel removed the portion of the backing bar, but did not perform back welding necessary to comply with AWS D1.5 2002.

- This issue was previously raised on 27-Oct-2010 (NCR# ZPMC-0839).

- Weld is a T-Joint Complete Joint Penetration (CJP) weld.

AWS D1.5 2002, Section 3.13.2: "Groove welds made with the use of steel backing shall have the weld metal thoroughly fused with the backing."

AWS D1.5 2002, Section 4.6.9: "CJP groove welds made without the use of steel backing shall have the root gouged to sound metal before welding is started from the second side."
